**Subject: Visual Clearance Inspection Report Paint Removal for IPWP1**

**Site Address:** 3100 Airport Way S  
Seattle WA

**NVL Project #:** 2012-494

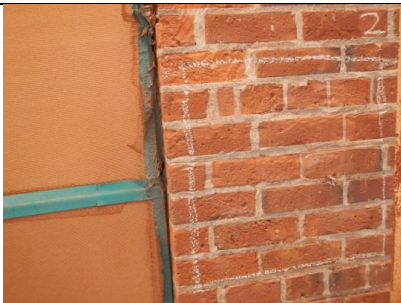
No
3	57

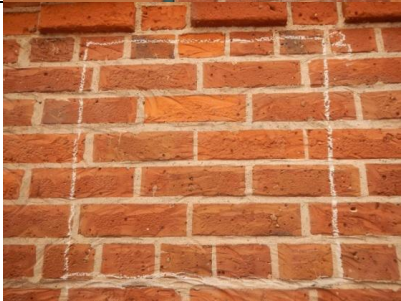
No
6	227

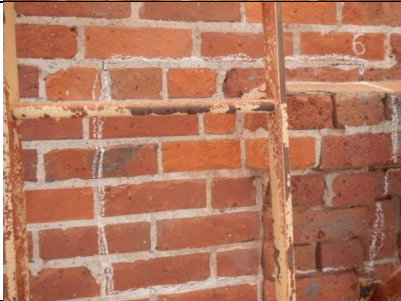
Yes- Red paint in mortar
7	280

Requirement 2 of Condition 7 of EPA's approval for IPWP1 states *"If paint remains after blasting is conducted additional remediation is necessary to meet the terms of this approval."* The Contractor was advised and additional remediation was carried out to satisfy the requirements of the Work.

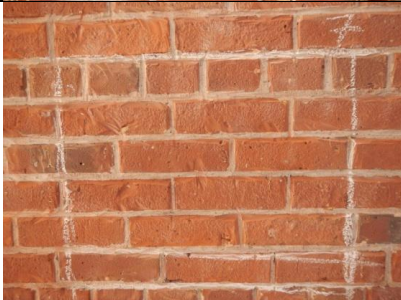
No
8	334

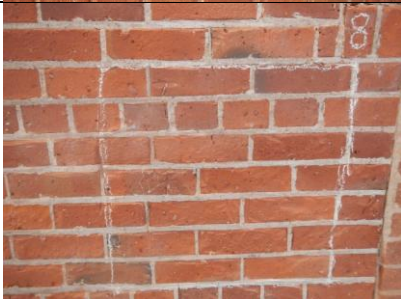
No

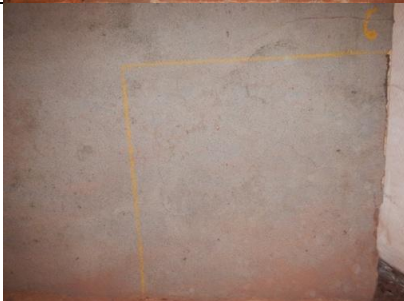
Yes- Red paint on concrete at the bottom of the grid square.

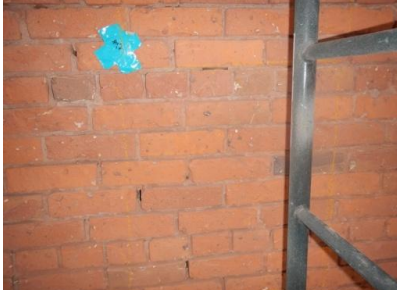
No
12	385

No
6	374

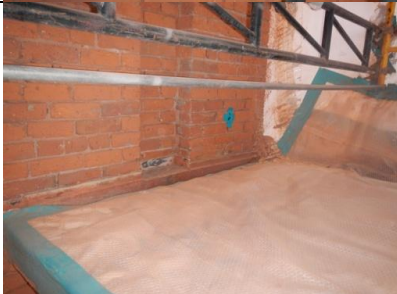
No
4	377

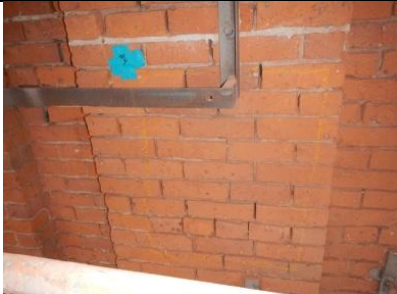
No
8	416

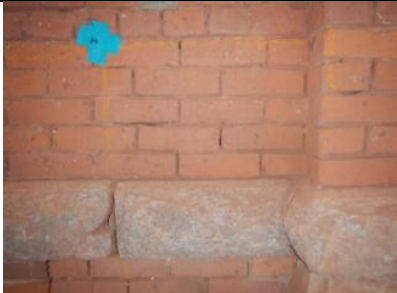
No

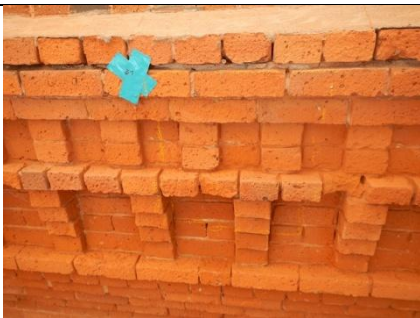
Random Count #	Grid #	Photo	Paint Still Present?
7	35

No
6	64

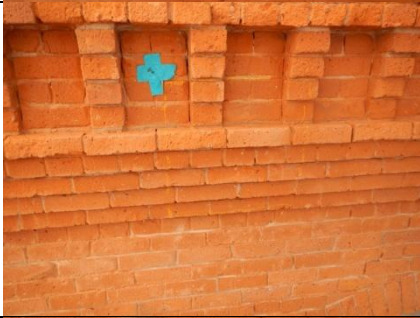
No
9	119

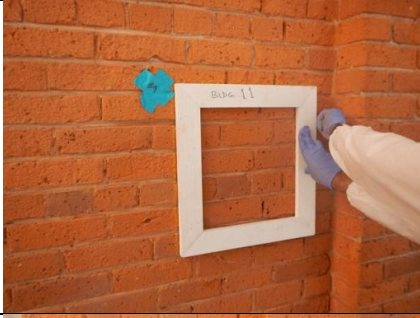
No
13	141

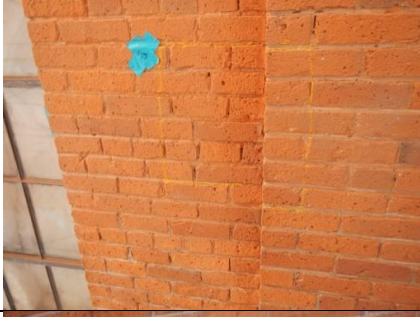
No
11	257

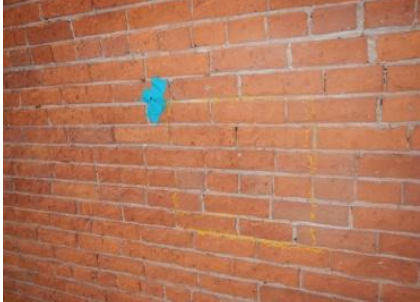
No

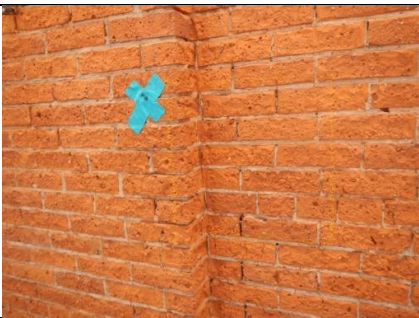
Random Count #	Grid #	Photo	Paint Still Present?
10	195

No
1	286

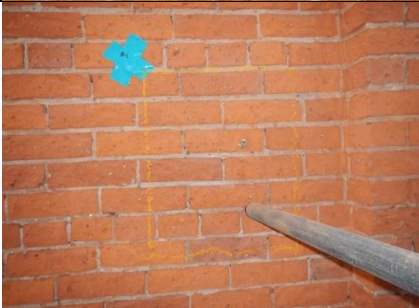
No
2	290

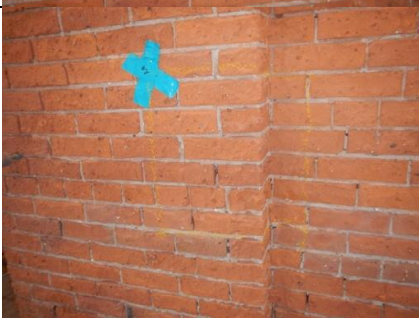
No
3	361

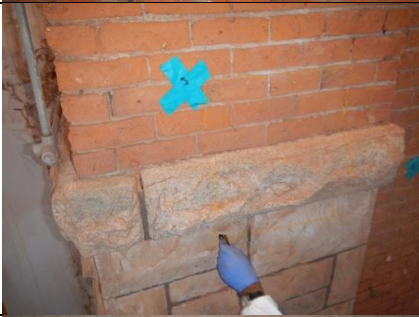
No
4	470

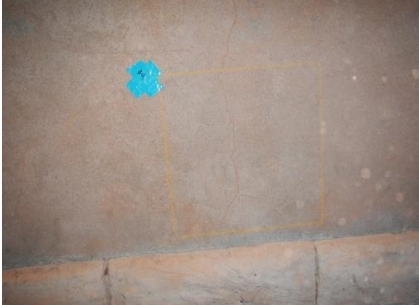
No
